Bradford Road, Bailiff Bridge
*Phase 2 Geo-Environmental Investigation
and Assessment Report*

G2240-GR-02-o

6th June 2016

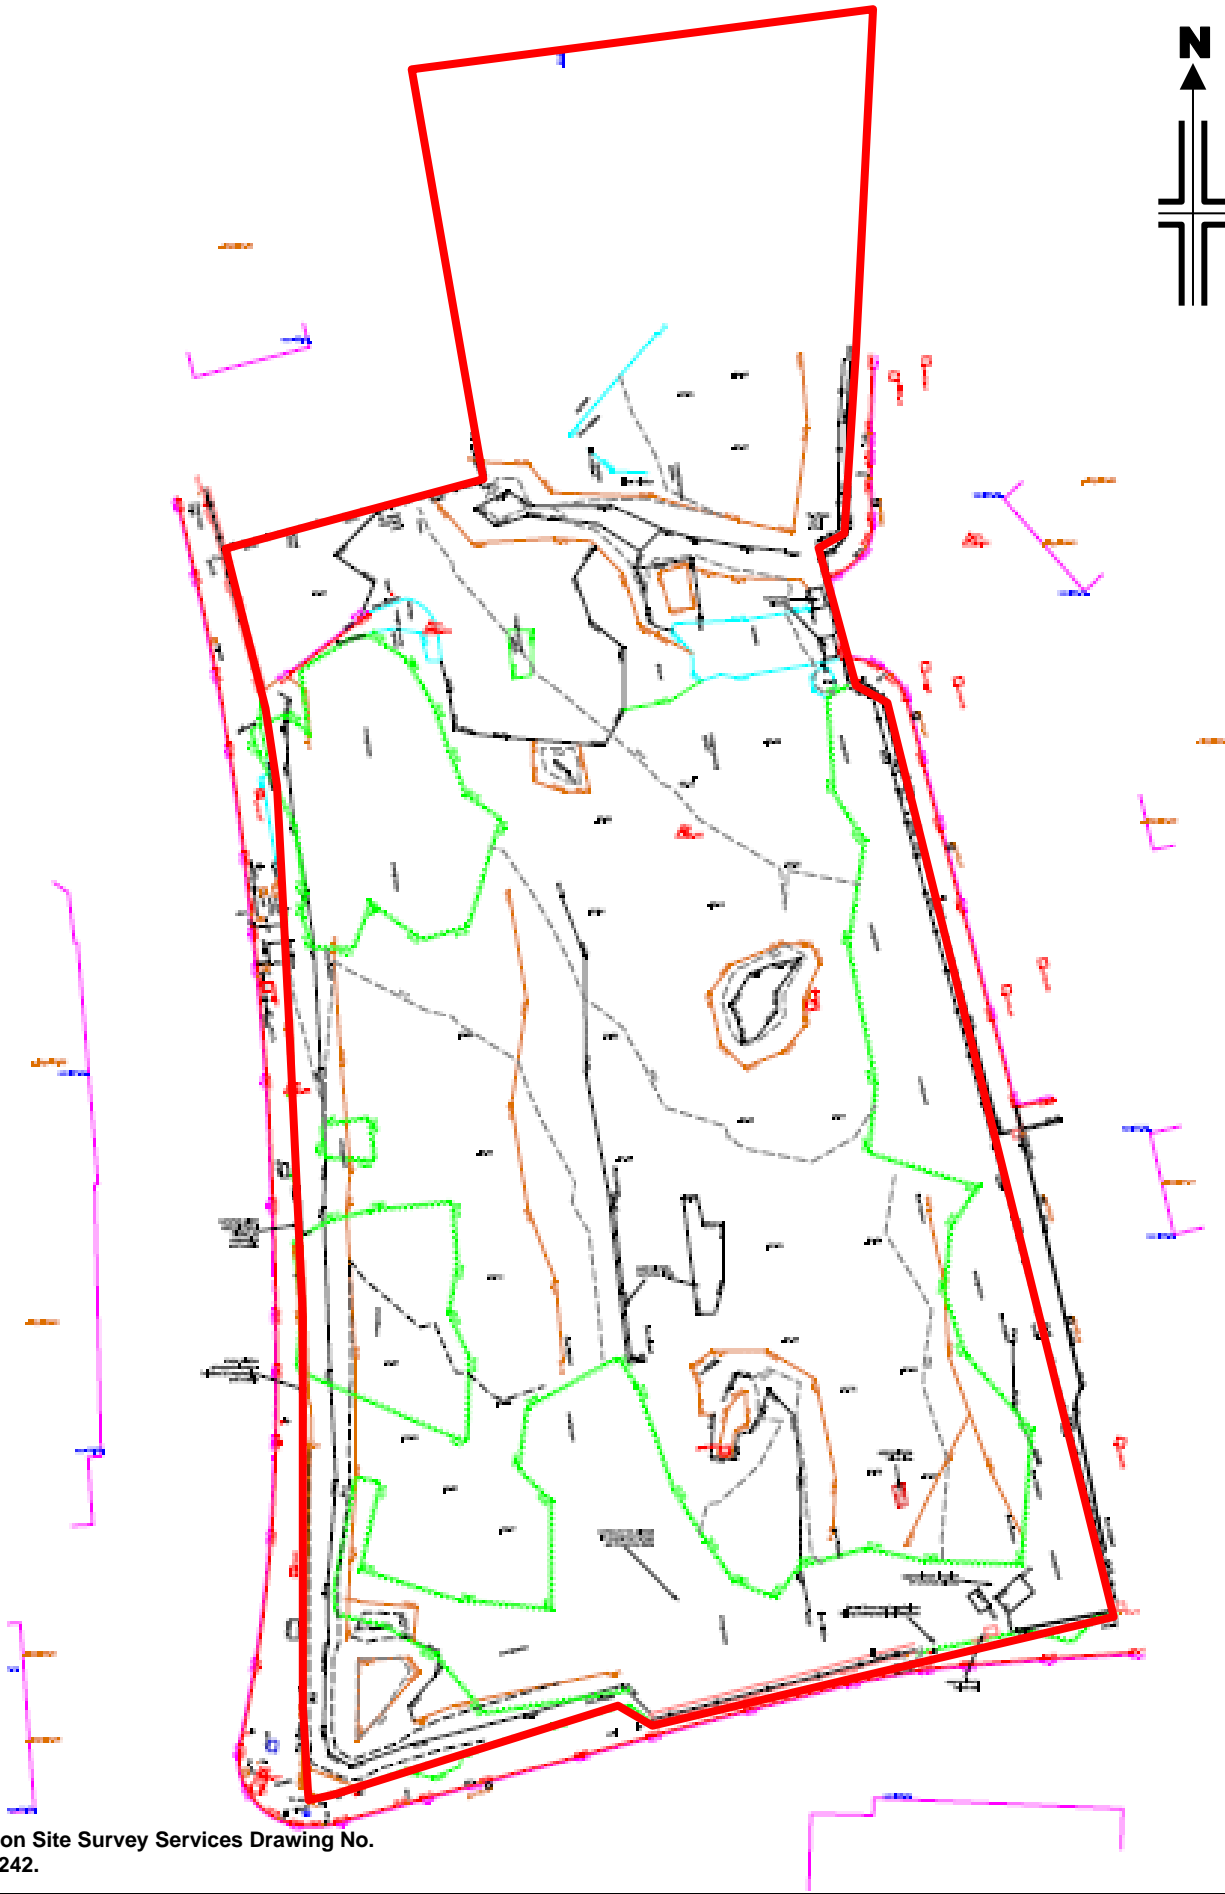
ML (WOOLER) LTD			
GROUND INVESTIGATION PLAN BRADFORD ROAD BAILIFF BRIDGE		Scale 1:200@A1	
		Drawn AR	Checked JB

Technique	Date	Exploratory Holes	Final Depth(s) & Location	Remarks
		<i>Logs in Appendix A</i>	<i>Ground Investigation Plan (Drwg G2240-06)</i>	<i>Lab Testing in Appendix B+C.</i>
Window Sample Vertical Boreholes	16-17/02/16	WS1	4.30mbgl [Central E area-proposed centre of building]	General ground conditions, sampling for lab testing, in-situ testing, well installation.
		WS2 WS2A	0.72mbgl 4.30mbgl [SE area-proposed SE corner of building]	General ground conditions, abandoned due to impenetrable fill material, sampling for lab testing, well installation.
		WS3	4.50mbgl [SE area – car park and landscaping]	General ground conditions, sampling for lab testing, in-situ testing.
		WS4	6.70mbgl [Central area-proposed SW corner of building]	General ground conditions, sampling for lab testing, in-situ testing, well installation.
		WS5	4.10mbgl [SW area – car park and landscaping]	General ground conditions, sampling for lab testing, in-situ testing.
